Structural rehabilitation of sewer manhole

Municipality of Zuidhorn.

Location: Grijpskerk

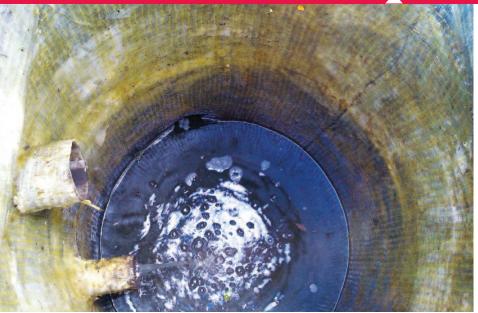
The rehabilitated manhole suffered from leakages and concrete surface deterioration due to mild levels of H2S. This H2S gas buildup came from an incoming pressure pipeline. If this situation would have continued, it would have caused high replacement cost and social economic disturbance in the long term. Firstly the connecting pipes were turned off and the concrete surface was prepared thoroughly. Then the specially designed Tyfo® WP Epoxy was used as a primer at the wet substrate for bonding purposes to our Tyfo® Fibrwrap® System. This system consists of two layers of glass fiber Tyfo® SEH-51A saturated with Tyfo® S Epoxy. Lastly the Tyfo® HCR (High Chemical Resistance) Epoxy coating was applied to the FRP surface to provide a durable, cost effective solution with reduced future maintenance cost and long term protection to (bio)-chemical gasses and liquids that exist in these environments. The whole project was completed in only two days.
