## Emergency repair of masonry of Renocentese Bell Tower, Emilia-Romagna, Italy

Project: Emergency repair of masonry of Renocentese Bell Tower, in Italy

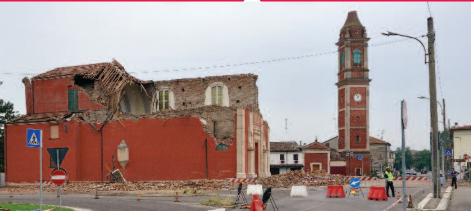
After the first phase, which entailed the application of a fiber-reinforced concrete jacket with shotcrete technique at the bottom part of the tower, then a combination of Tyfo® FIBRWRAP® Systems both Glass (SEH) and Carbon (SCH) was used to wrap the lower part of the belltower, in 2 layers, creating this way a sort of vertical and horizontal supporting grid.

Finally the cracks of the masonry wall were repaired by injection of a specially mixed lime based mortar from the inside of the bell tower.
