### Strengthening of Stalloni Gallery, San Rossore Estate, Massaciuccoli, Italy

**Project:** Strengthening of Stalloni Gallery, San Rossore Estate, in Italy

**Location:** Massaciuccoli, Italy

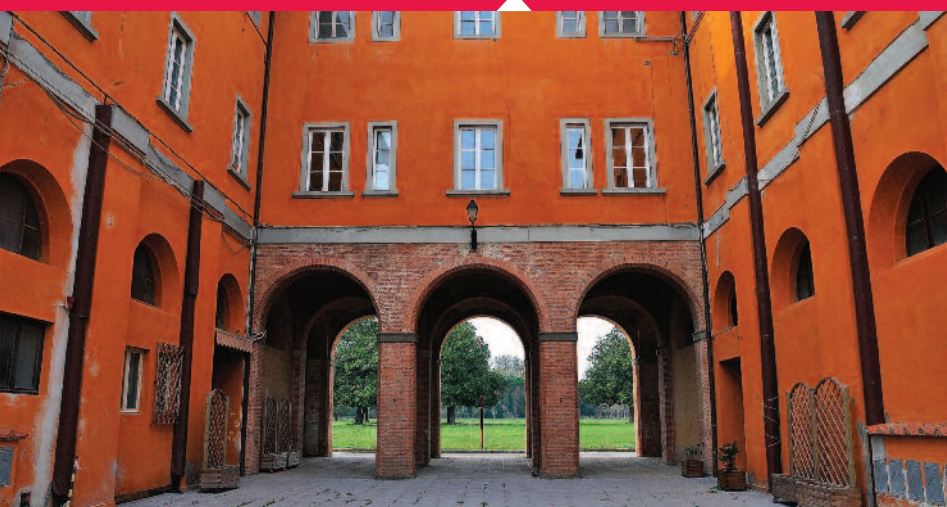
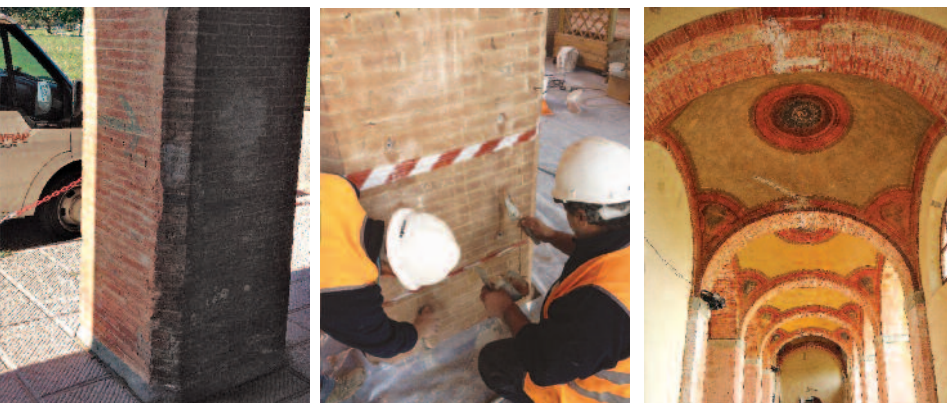
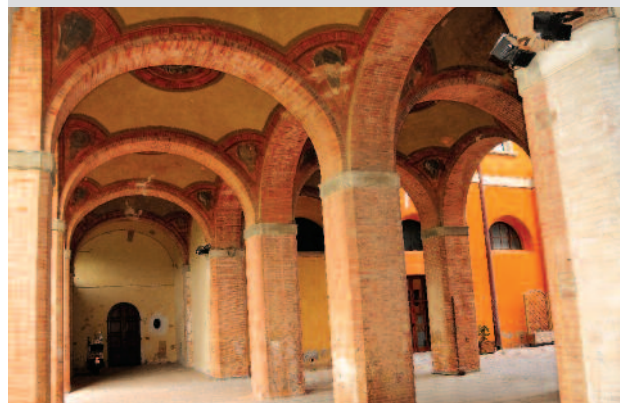
The "Stalloni" Gallery (loggia), constituted by a series of arches and vaults supported by columns of masonry is part of the San Rossore Estate. Several cracks along the columns and the arches of the building were evident and in need of repair.

Fibrwrap provided a design build solution which entailed the realization of grooves along every cracked column, in which have been inserted bars of carbon fibers, with the use of lime mortar of high resistance. The same procedure has been also used to at the cracks of the arches keys, replacing though the lime mortar with an epoxy resin of high viscosity, so as to successfully inject at the overhead locations. Finally, the cracks present on the vaults, arches and columns have been repaired with lime mortar.

The dust extracted during the grooves execution has been collected and mixed with lime mortar and has been applied on the interventions location in order to "disguise" them in the best way.
