Location: Isle of Milos, Greece Client: S & B Industrial Minerals

Project: Structural Repair and

Strengthening of 4 silo Perlite complex of S&B Industrial Minerals

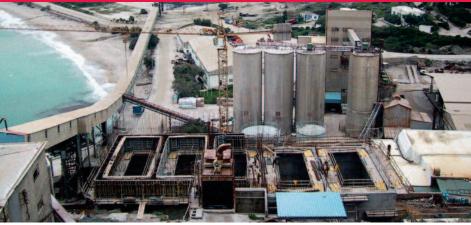
The silos were built in 1972 for storing perlite fractions and subsequently loaded to ships through a conveyor belt. The complex consists of four silos of 30 m high and 8m diameter with a storage capacity of 1.500 m³ each one. Due to the proximity to the sea front severe problems of reinforcement corrosion and carbonation of the concrete became apparent. The initial method of repair was to apply a jacket of concrete at all silos. After a period of time it was discovered that the foundation bearing rings had cracks due to the added load of the concrete jacket.

Fibrwrap was then called in and prepared the structural design, the technical specifications of operations, took over the supervision of the project and performed the part of the project involving the structural strengthening of the foundation bearing rings with application of Tyfo Fibrwrap Systems of SCH Carbon Fibers and Tyfo Epoxies.

Structural Strengthening & Repair of Bearing rings with **FRP**
