**Project:** Structural Strengthening  
Perlite silo of S&B  
Industrial Minerals

**Location:** Island of Milos, Greece

### Structural Strengthening Perlite silo of S&B Industrial Minerals, Milos Island, Greece.

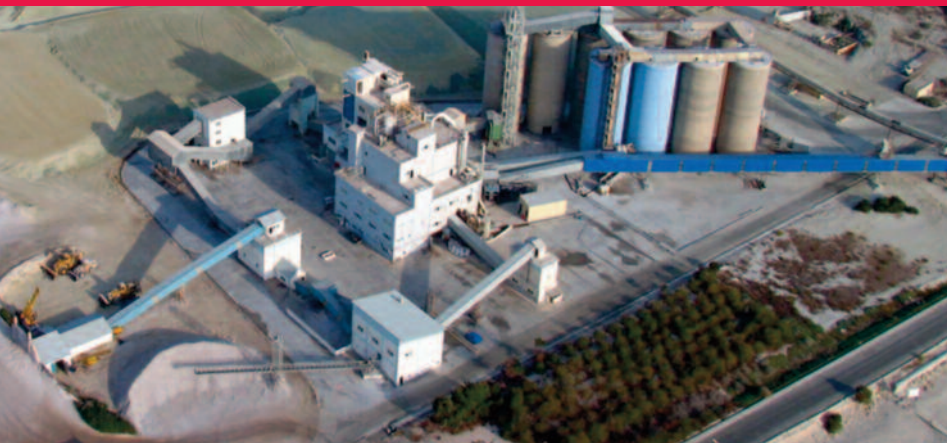
Presence of vertical cracks at all the height of the silo required inspection that indicated degradation of the concrete cover followed by severe corrosion of the hoop reinforcement. The requirement was for a strengthening method durable enough to withstand the severe environment that would rehabilitate the silo fast and without adding weight to the structure.

The repair consisted of deposal of the degraded concrete, sandblasting of the corroded reinforcement, application of corrosion inhibitors and application of external shotcrete layer to rehabilitate the initial section geometry. Tyfo® SCH-41 System was chosen in order to replace the missing hoop reinforcement and fully restore the silo capacity. A special saturator device was used for the Tyfo® SCH-41 wet lay-up application.
