### Structural repair of Interstate 94 Overpasses, Wisconsin, USA.

**Project:** Structural repair of  
Interstate 94 Overpasses

**Location:** Wisconsin, USA

**Client:** Wisconsin Dept of  
Transportation

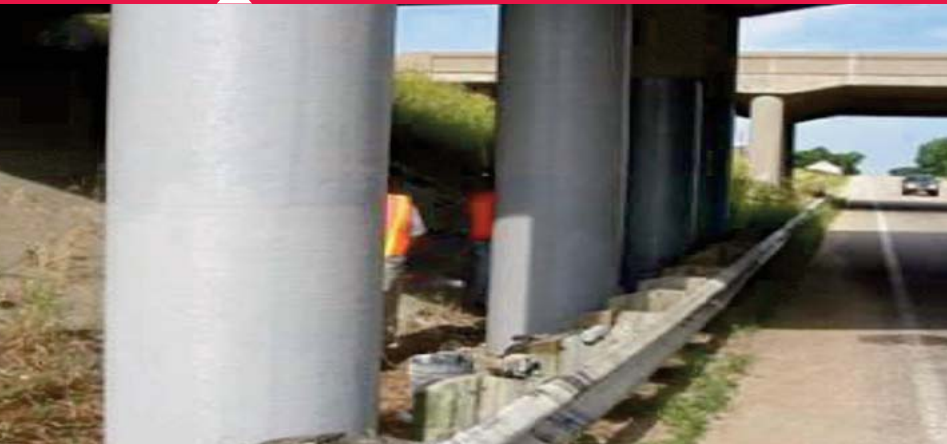
Many columns on numerous bridge overpasses showed signs of corrosion at the mid-height down to the base. The severe spalling and associated deteriorated reinforcement was mainly due to the close proximity of the columns to the busy Interstate. Constant splashing of snow and slush during the winter season enabled de-icing materials to deteriorate the concrete and reinforcement. The most severe corrosion was evident in the reinforcing ties. Loose cover concrete was removed and the existing concrete and rebar were treated with the Tyfo® Corrosive Inhibiting Systems. The Tyfo® P Epoxy-Mortar patching material was then used to restore the original sections of the columns. Lastly, the columns were wrapped with the glass-based Tyfo® SEH-51 Composite System.

The non-corrosive composite wrap provides future protection from de-icing infiltration and also provides confinement strengthening replacing the ineffective, deteriorated tie reinforcement.
