FIBRWRAP NEDERLAND B.V.

### Structural rehabilitation of oil pipelines, Oiltanking Amsterdam

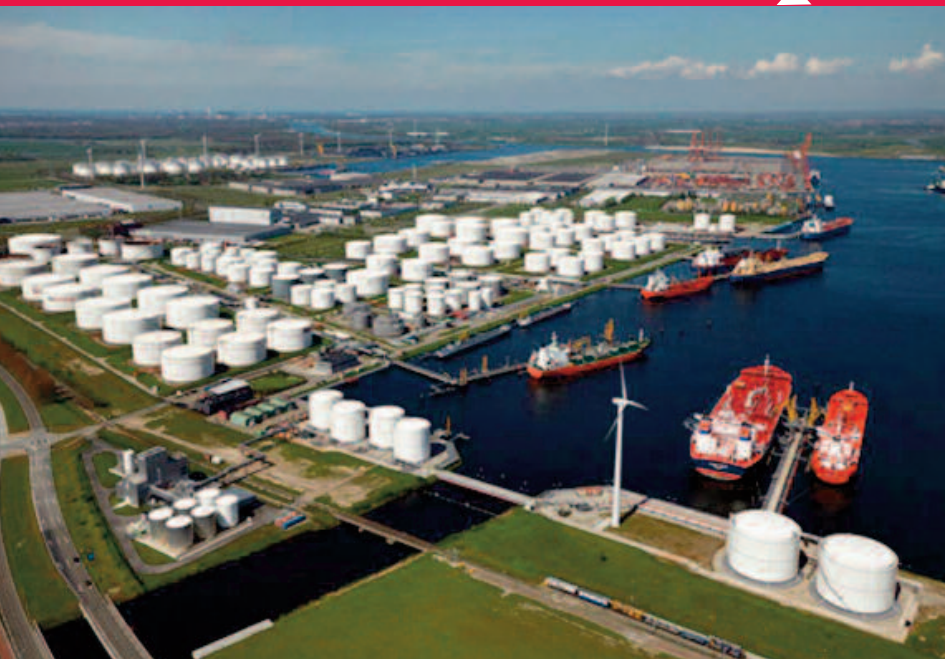
The rehabilitated pipelines suffered from corrosion. Continued deterioration of the pipelines could lead to structural failure in the long run, with leakage as a result. This would have had a major impact on production capabilities and unpredictable collateral damages. All with very high cost involved.

The connected pipes were still in use as the steel surface of the tank and pipelines were thoroughly prepared to ensure proper bonding. Then the specially designed Tyfo® TC Epoxy was used as a primer on the steel substrate for bonding purposes to our Tyfo® Fibrwrap® System. This system consisted of three layers of glass fiber Tyfo® SEH-25A saturated with Tyfo® S Epoxy. Lastly a polyurethane coating was applied to the FRP surface to provide a durable resistance to all elements.

The whole project was completed in eight days.
