Project: Rehabilitation of a pumping station

Location: IJsselstein

Structural rehabilitation of pumping station,

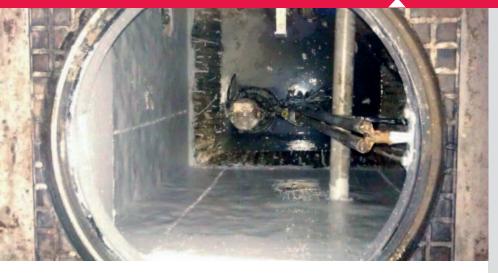
A pumping station, due to exposure of high levels of H2S gas from several incoming pressure pipelines, suffered from concrete surface deterioration.

Flbrwrap Netherlands provided a solution for rehabilitation and strengthening of the existing structure with the application of Tyfo Fibrwrap Systems. This enabled the owner to avoid high replacement cost and social disturbance in the long term.

The systems used comprised of Tyfo WP epoxy as primer for wet substrate, Tyfo WS epoxy for restoration of cross-section area, application of Tyfo Glass Fiber SEH-25A with Tyfo S Epoxy and finally Tyfo HCR as coating for protection for the whole rehabilitated surface against H2S gasses.
