### Rehabilitation of sewer manhole

Municipality of Velsen.

**Project:** Rehabilitation of a sewer manhole

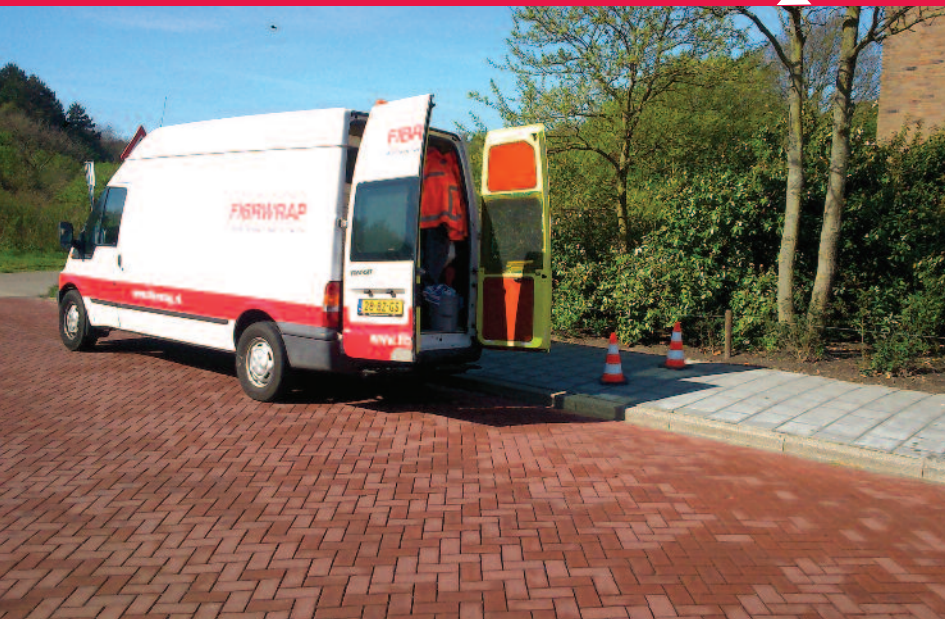
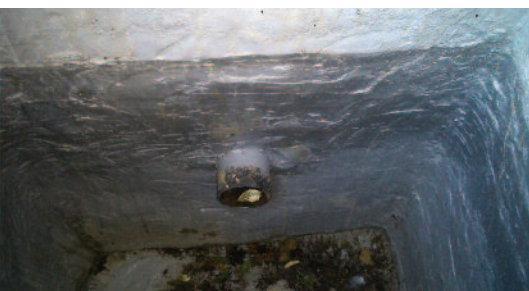
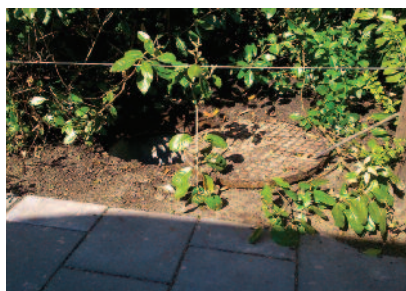
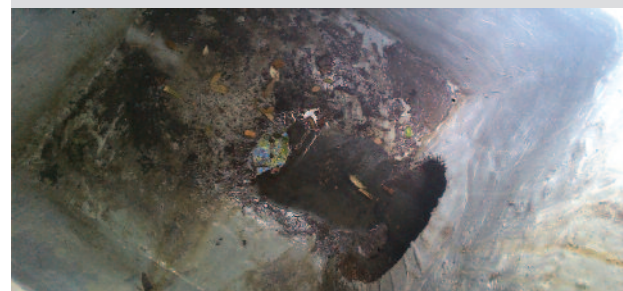
The rehabilitated manhole suffered from concrete surface deterioration due to high levels of H<sub>2</sub>S gas. This H<sub>2</sub>S gas buildup came from an incoming pressure pipeline. If this situation would have continued, it would have caused high replacement cost and social disturbance in the long term, since the manhole is located in a garden. Firstly the inflow pipes were temporally blocked, then the concrete surface was thoroughly prepared and lost sections repaired. Afterwards the Tyfo® HCR (High Chemical Resistance) Epoxy coating was applied to the concrete surface to provide a durable, cost effective solution with reduced future maintenance cost and long term protection to (bio)-chemical gasses and liquids that exist in these environments. The whole project was completed in only one day.

- Rehabilitation of a waste water manhole
