### Rehabilitation of a steel pipe of Dominion Pipe, Yorktown, USA.

**Project:** Rehabilitation of a steel pipe of Dominion Pipe

**Location:** Yorktown, USA

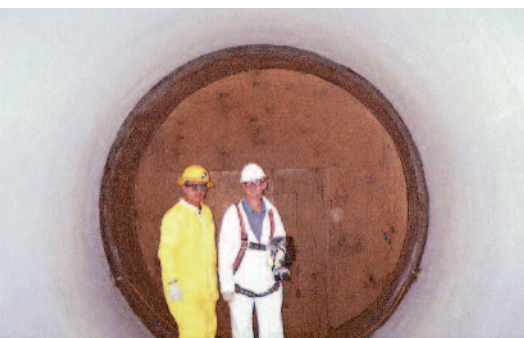
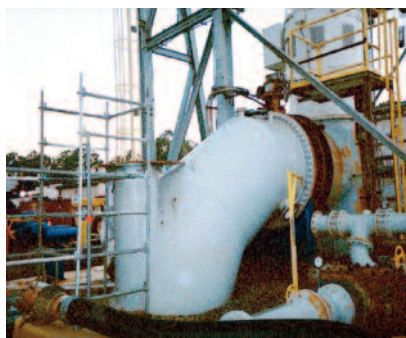
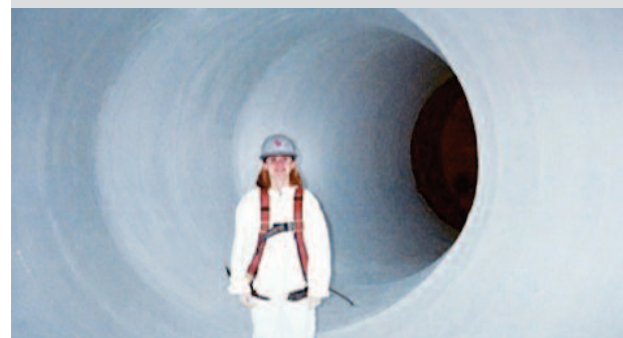
The 120" diameter steel pipe at this power plant was severely rusted due to the corrosive environment. A repair solution was needed that could withstand the harsh environment and be installed with minimal shut down time at the plant. A repair solution was designed using the Tyfo® Fibrwrap® System. One layer of the Tyfo® SEH Glass Composite System was installed longitudinally in the pipe. This was followed by one layer of the Tyfo® SCH Carbon Composite System. The glass composite provided strength in the longitudinal direction as well as acting as a dielectric barrier between the steel and the carbon fibers. Small crews certified to work in confined spaces installed the composite materials during regularly scheduled shut down times. A unique scaffolding system was designed to allow access to all sides of the pipe at one time. This ensured that the circumferential layer of the composite could be applied continuously around the pipe.

The FRP Composite Solution to this pipe deterioration provided a quick repair technique to repair the deteriorated steel. There was minimal impact on the power plant operations and the solution will hold up well in this aggressive environment.

- Strengthening and Rehabilitation of a large diameter steel pipe
