# FIBRWRAP®

### Pipe strengthening of SDCWA Fallbrook, Fallbrook, USA.

**Project:** Pipe strengthening of SDCWA Fallbrook

**Location:** Fallbrook, USA

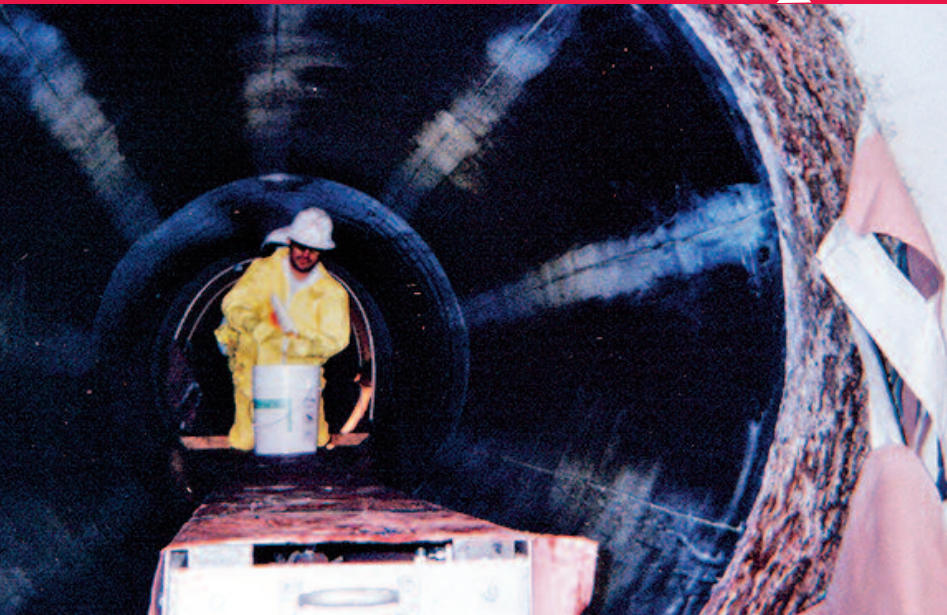
Three 96" diameter PCCP sections at the San Diego County Water Authority were deemed structurally deficient due to corrosion. Fibrwrap® Construction was contracted to provide the required repair.

The Tyfo® Fibrwrap® System was designed to resist the loads from the earth's pressure, live loads, and internal pressures. 1 layer of the carbon-based Tyfo® SCH-41-2X System was installed in the longitudinal direction and 8 layers in the hoop direction to restore the pipe back to working capacity.

Fibrwrap® Construction was able to mobilize quickly and perform the repair in an effective and timely manner, resulting in time savings and shut down time.
